Research Report 1434

**Human Factors Assessment:
Light Armored Vehicle,
Maintenance/Recovery Vehicle (LAVM/RV)**

**ARI Field Unit at Fort Hood, Texas
Systems Research Laboratory**

December 1986

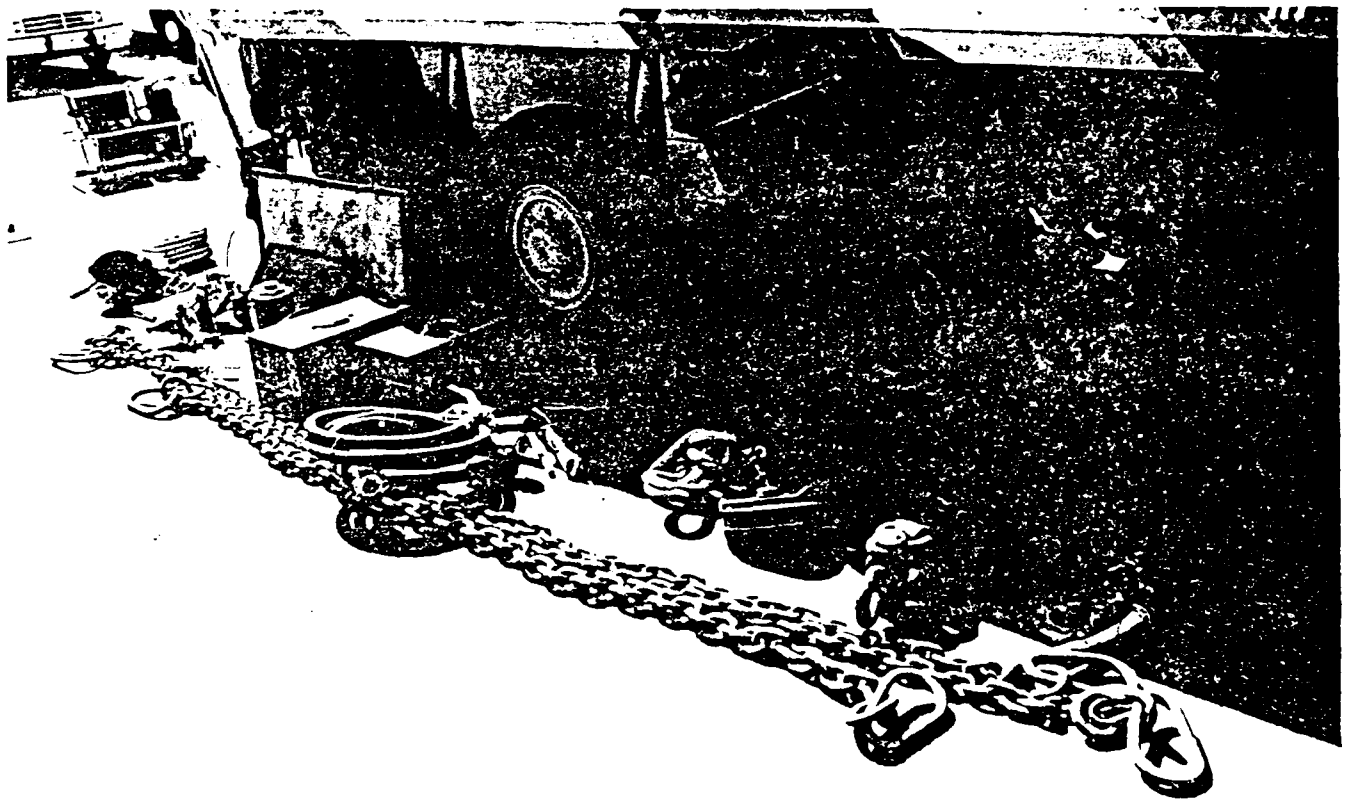
Tool and accessory storage. Crews rated the size and location of storage and the protection of equipment in storage as borderline (average mean rating, 3.1, see questionnaire items 43 to 46). Figure 11 shows the equipment carried in internal vehicle storage locations. Figure 11, however, does not show any combat gear which is also stored inside the vehicle. Figure 12 shows the equipment as it is usually stored in the vehicle. Notice that stored equipment is blocking the passageways. Figure 13 shows two of the three secure storage spaces allocated for all the equipment shown in Figure 11. Secure storage consists of two equipment trays (measuring 26 x 7 x 7 in (66 x 18 x 18 cm)) and one tool box (measuring 19.50 x 13.25 x 10 in (50 x 34 x 25 cm)). The lack of secure storage locations results in the stacking of equipment in any available space. The crew also reported that they stored equipment in their seated legroom and carried equipment in their laps when the vehicle was combat loaded. The lack of secure storage results in several problems, including:

Figure 11. The equipment carried inside the vehicle. Additional combat gear is not shown.
